Explosion of lithium-thionyl-chloride battery due to presence of lithium nitride

Hennesø, E.; Hedlund, Frank Huess

Published in:
Journal of Failure Analysis and Prevention

Publication date:
2015

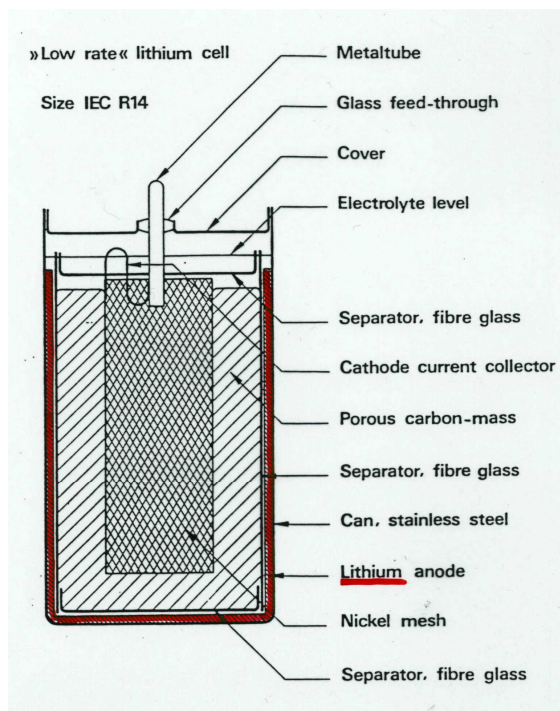
Figure 1 Schematic construction of accident R14 cell

The accident cell was a R14 stainless steel (type 304) container with metallic lithium foil as anode, thionyl chloride as cathode, compressed powdered carbon and nickel mesh as current collector and a glass fibre nonwoven separator (**Figure 1**). The lithium foil thickness was 1.4 mm. The electrolyte was prepared adding AlCl₃ and LiCl salts to anhydrous SOCl₂ to yield a solution of 1.73M LiAlCl₄, about 300 g/l. Henceforth, the article will refer to this solution as the thionyl chloride electrolyte, or simply the electrolyte.
